Manhole Inspection Summary

Manhole # S35KK1006MH

Insp Date: **3/12/07 11:50 AM**

Location Address: **403 MARLOW RD**

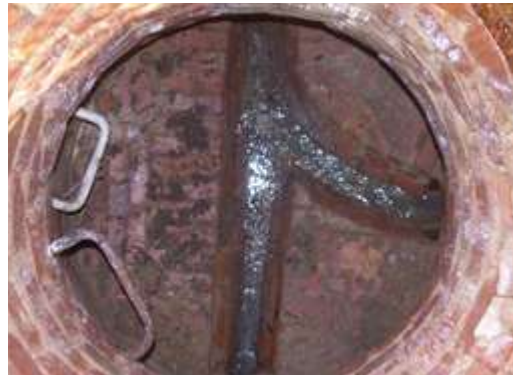
Top View

Corroded steps. Bench debris.

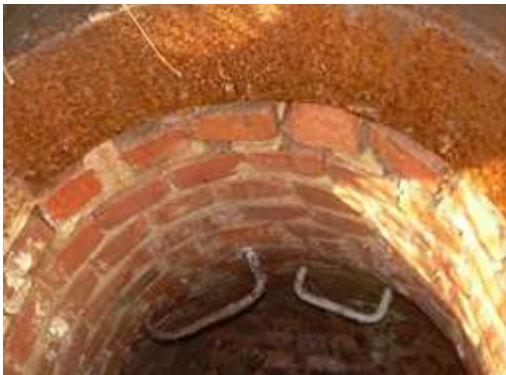
Defect

Adjustment deterioration and infiltration.
Corbel and Barrel infiltration.

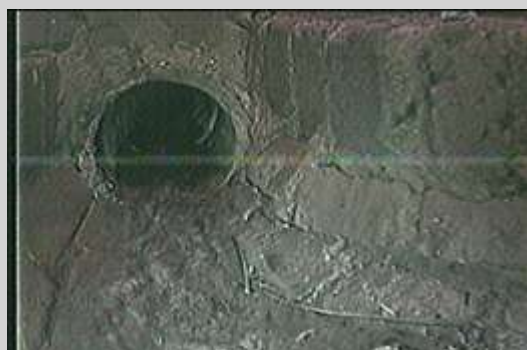
Pipe Out @ 12 O'Clock

Channel deterioration.

Infiltration: **Evidence** Pipe Seal Cond: **Cracked**

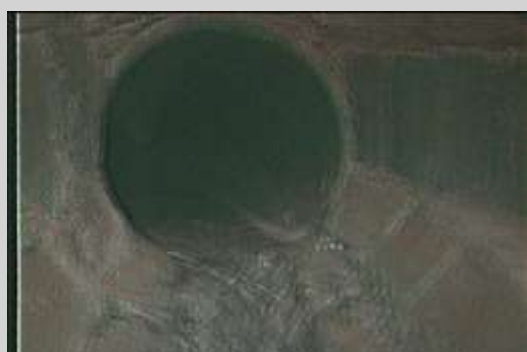
Pipe In @ 3 O'Clock

Infiltration: **None** Pipe Seal Cond: **Unknown**

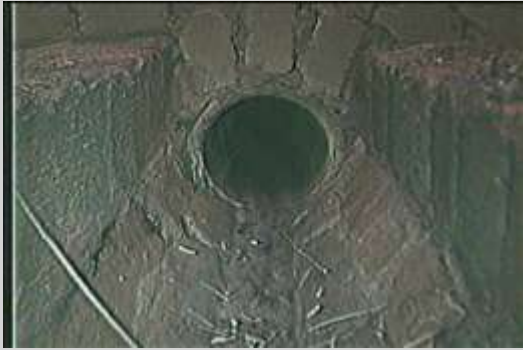
Pipe In @ 6 O'Clock

Deposits: ☐ None ☐ Mud ☐ Sludge ☒ **Debris** ☐ Grease

Deposits Extent: **Light**

Infiltration: **Evidence**
